DAM INSPECTION CHECKLIST POSSUM POINT POWER STATION POND ABC

INSPECTION DATE: APRIL 26, 2016

INSPECTED BY: K. ACRE

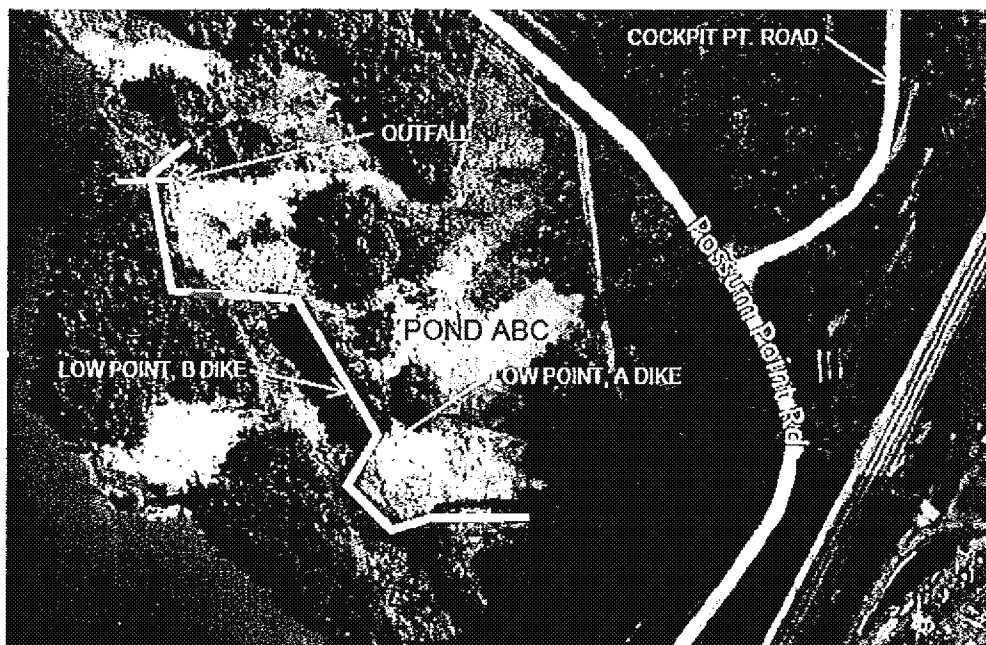
* See figure below.

| Location/ Condition | (y/n) | Change (y/n) | Comments |
|--|---|---|---|
| Low Point, A dike* | | | |
| Flow | N | N | 8:18 → NO STANDING WATER AGAINST SAND BAGS, AND SAND BAGS ARE IN-PLACE AND RIPRAP ARE IN-PLACE. |
| Erosion | N | N | SEVERAL SAND BAGS ARE RIPPED. |
| Low Point, B dike* | | | |
| Flow | N | N | 8:26 → NO STANDING WATER AGAINST SAND BAGS AND SAND BAGS ARE IN-PLACE. |

Additional Comments (Note any changes observed along the embankment crest or downstream slope observed from the crest.): LOW POINT, C DIKE → 8:33 → THERE IS NO FLOW, EROSION, OR STANDING WATER AGAINST SAND BAGS. SAND BAGS ARE IN-PLACE AND SEVERAL SAND BAGS ARE RIPPED.

SOME STANDING WATER PRESENT THROUGHOUT PONDS A, B, AND C. WITHIN POND LIMITS.
STANDING WATER AT TOP OF EMBANKMENT TO PONDS A, B, AND C. (SEE FIGURE BELOW).
